Expert's reports

Flooring system: BaseBeton with 2 K PU

Stone AGE BV supplied the flooring system. The system was applied to 2 samples.  
The following test was carried out:

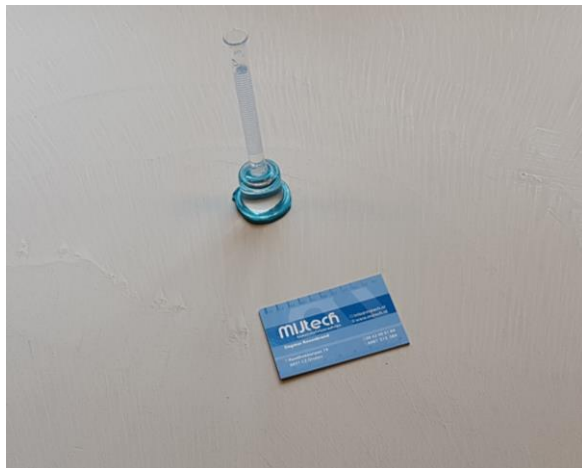
Karsten water absorption tester

A water absorption test gives an accurate answer to the question of water absorption per time unit / in volume / per surface unit.

The testing device, the "water absorption tester", has a glass bell with a diameter of round 30 mm and a welded calibrated measuring tube with volume indication (1 ml = 10 cm water column).

The bell of the water meter is sealed to the testing surface in an impermeable way.

Execution of the water absorption test on floors:

The "water absorption tester" is sealed with a plastic sealant, e.g. silicones, or the like, to the surface to be tested.

Pressing the bell tightly to the testing surface results in an impermeable connection.

In doing so, the sealant present within the bell will leave vacant a circle of approx. round 20 mm diameter, a testing surface of approx. 3 cm<sup>2</sup>.

For the test, the measuring tube is now filled with tap water by means of a squeeze bottle or an injector up to the zero setting, so that the testing surface will be under a pressure of approx. 10 cm WS.

During the water absorption, the bell is permanently pressed lightly by hand in order to prevent shifting as the glue is still plastic. At regular intervals, the water absorption is checked as from the zero setting.

As soon as 1 or 2 ml of water is absorbed, the measuring tube will be filled up again with water up to the zero setting in order to retain the pressure of 10 cm WS herein.

After 24 hours, no water was absorbed.  
After 2 x 24 hours, no water was absorbed.  
After 3 x 24 hours, no water was absorbed, end of test.

The material is impermeable and does not absorb water.

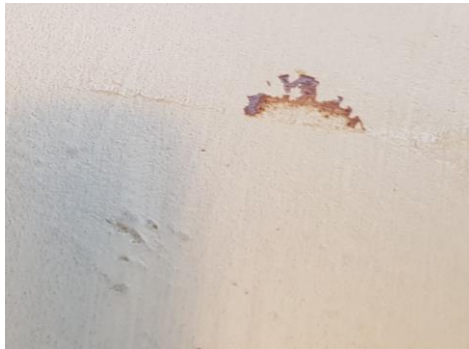
Coffee stain, half of it is removed

Coffee stain after evaporation: fully removable with a red cleaning pad and water.

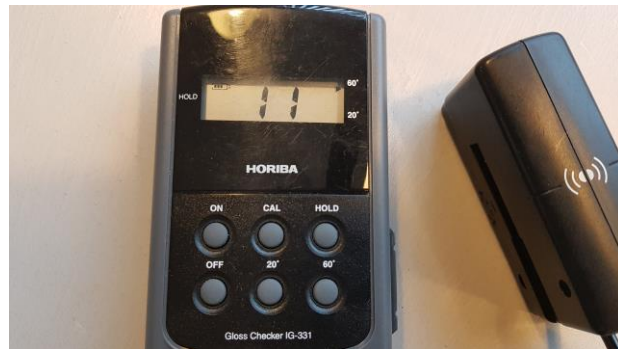
gloss measurement

Gloss level: 11 g.u.
